BLAST TESTS OF EXPEDIENT SHELTERS IN THE DICE THROW EVENT, (U)

ORNL-5347

## Blast Tests of Expedient Shelters in the DICE THROW Event

Cresson H. Kearny  
Conrad V. Chester

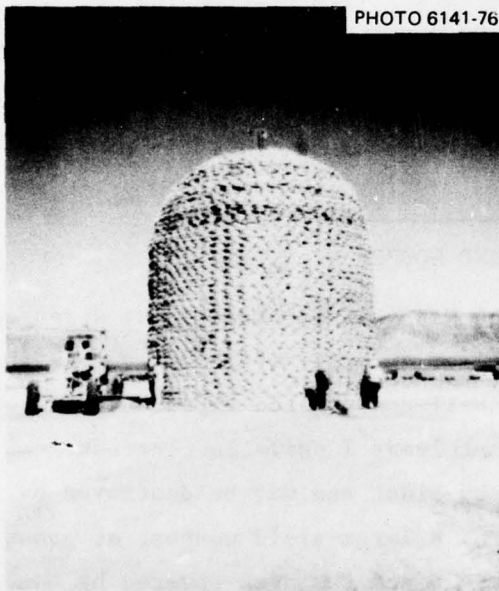
Fig. 1.1. The 628 tons of ANFO ready for detonation.

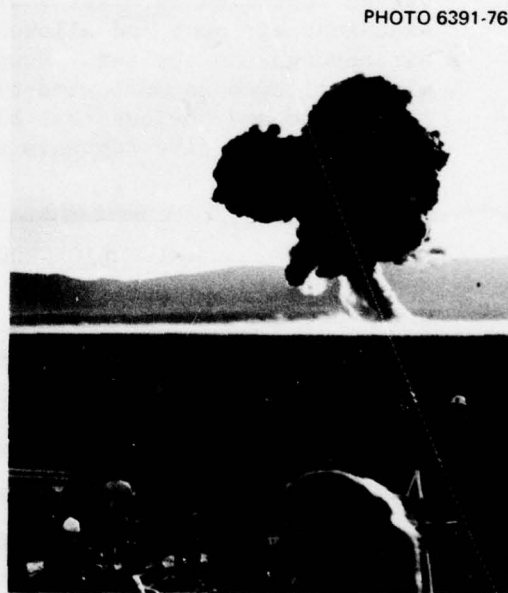
PHOTO 6391-76

Fig. 1.2. View of the rising mushroom cloud taken from an observation post 3 miles away.

Figure 1.2 is a photo taken 3 miles away from ground zero and shows the mushroom cloud while it was still rising. The winds of the negative

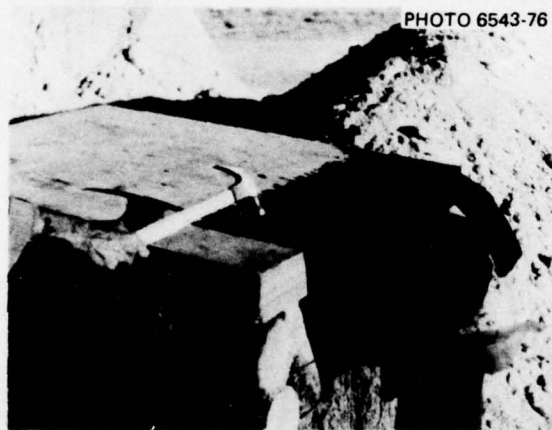
Fig. 4.3. Nailing tire-strip hinges to expedient blast door tested at the 53-psi overpressure range.

Both entrances of the Small-Pole Shelter were protected by expedient blast doors (see Figs. 4.3 and 4.4). Each door measured 48 x 42 in. and each was made of five thicknesses of 3/4-in. exterior plywood. The plywood sheets were glued together with waterproof resin and nailed together from both sides, on a rectangular spacing of 4 in. in each direction, with No. 16 (4-in.) coated nails. Expedient hinges made of strips cut from the worn treads of automobile tires were nailed to the

door and to vertical poles of the entry. A door was hinged on its side nearest ground zero with five hinges nailed with 5-in. nails to the five vertical poles of this side of its vertical entry. Each hinge was a 24-in.-long strip of worn, wide-tread automobile tire, 4 to 6-1/2 in. wide and 1/4 to 1/2 in. thick, measured in the grooves of the tread. Each strip was nailed to its door with twelve 5-in. nails, driven in about 3-1/2 in., with their heads bent away from the hinge line.

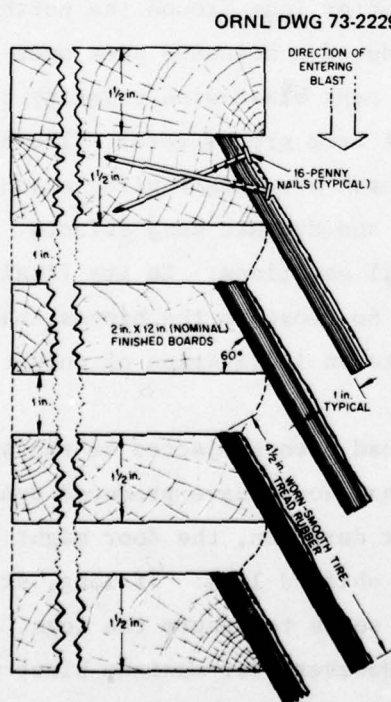
Fig. 4.5. Vertical cross section through an overlapping-flaps blast valve. The tested valve had four open-air slots, each 1 in. high and 10 in. wide. The overall width of the housing was 18 in.

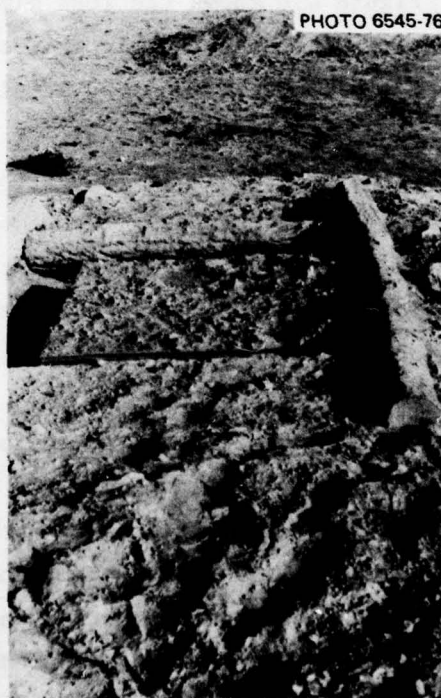
Fig. 4.6. Blast-protector logs around blast door after these logs were moved by blast effects at the 53-psi overpressure range.

There was no damage to any of the life-support equipment in this shelter, except for quickly repairable damage to the expedient shelter ventilating pump (KAP)<sup>13</sup> pictured in Fig. 4.6. (Without the protection of closed blast doors, a KAP or any other pump securely installed in an entry would be wrecked by the entering shock wave and blast winds, even at ranges as low as 3 to 4 psi. Without forced ventilation, below-ground shelters cannot be fully occupied in warm or hot weather. However, a KAP can be installed so that a shelter occupant can detach it and move it out of the way in the few seconds between seeing the very bright light from a large nuclear explosion and the arrival of the shock wave at lower overpressure ranges.<sup>13</sup>)

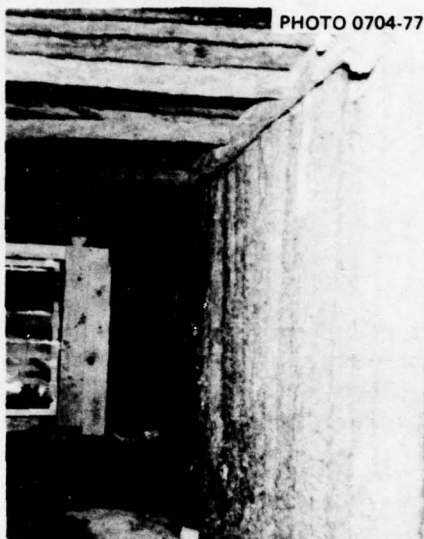
PHOTO 0704-77

Fig. 4.7. Small-Pole Shelter after being tested with blast doors closed at the 53-psi overpressure range. Note the slightly damaged expedient shelter ventilating pump in the stoop-in entryway. Two men worked about 5 min to replace the four blown-loose flaps, the only damage.

The pole frame and plywood blast doors of the Small-Pole Shelter were essentially undamaged by the blast effects at the 53-psi overpressure range (see Fig. 4.7). However, occupants would have been injured if they had been standing with their heads close to the ceiling, which was rapidly depressed when pressure on the roof poles caused the wall poles to be punched down into the soft, backfilled earth supporting them. This downward movement of the roof and walls varied from a minimum of 2 in. in the southwest corner to a maximum of  $6\frac{1}{4}$  in. in the northeast corner. Figure 4.8 shows the movement at the center of the room, where the upper part of the shelter was moved  $4\frac{1}{4}$  in. away from ground zero and  $4\frac{3}{16}$  in. downward, relative to the "fixed" vertical post to which the lower part of the damaged deflection gauge was attached. Furthermore, about 15% of the floor area "puffed up" from 2 to 8 in. above its original elevation.

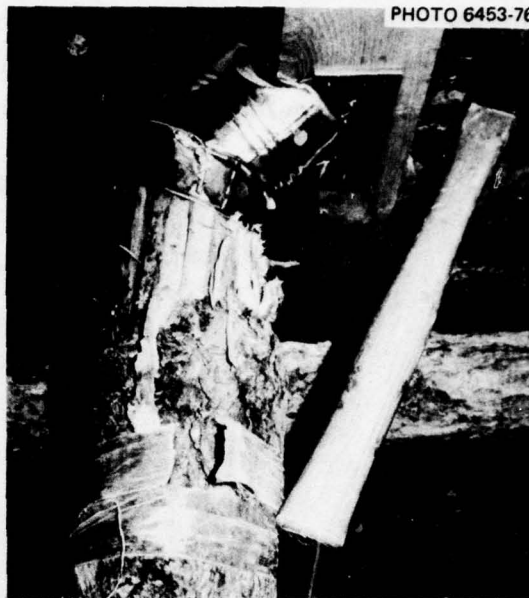
PHOTO 6453-76

Fig. 4.8. Movement of upper part of Small-Pole Shelter away from ground zero due to blast effects at 53-psi overpressure range.

The whole roof, the upper horizontal braces, and the upper ends of the wall poles were all displaced about 4-1/4 in. to the west (away from ground zero) by the blast effects on the 5-ft-high mound of shielding earth over the shelter. The sides of this mound sloped about 36°; its width on top averaged about 10 ft. (If this dry mound had been subjected to the blast effects of a megaton or larger nuclear weapon at the same 53-psi overpressure range, the much greater impulse and longer-duration drag effects might have caused the earth mound to be displaced far enough to wreck the underlying pole shelter — especially since the long-duration blast winds would have scoured away most of the cover of very dry, loose earth. Even a mound of wet earth, which is much less vulnerable to long-duration blast-wind scouring, might have been displaced far enough to cause serious or disastrous structural damage.)

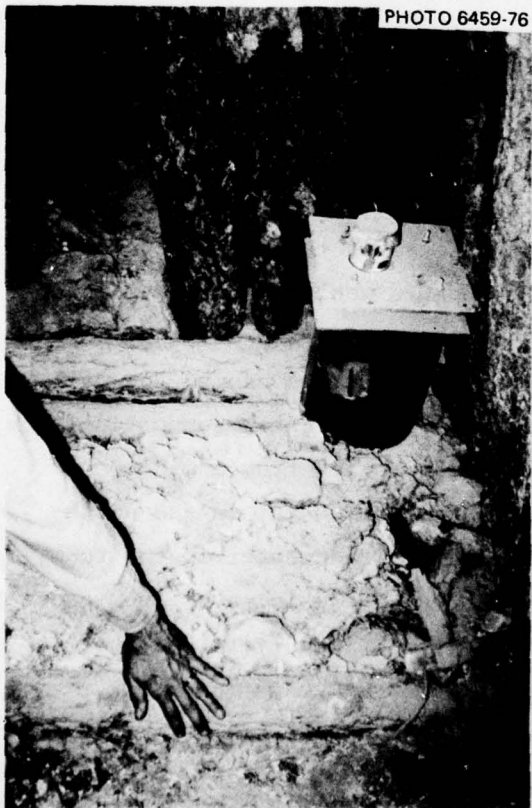
PHOTO 6459-76

Figure 4.9 shows how the floor "puffed up" about 6 in. in the northeast corner of the shelter in the east entryway; pressurized earth caused some earth to "flow" up into the closed room, in which the measured peak

Fig. 4.9. "Puffed-up" part of the floor of Small-Pole Shelter due to the start of earth flow under moderately long-duration blast overpressure at the 53-psi overpressure range.

4.4.2. A modification of this shelter with a continuous pole floor under the wall poles should not fail as a possible result of a large amount of pressurized and destabilized earth flowing up into it through its floor when subjected to the long-duration overpressures and large movements caused by a megaton explosion.

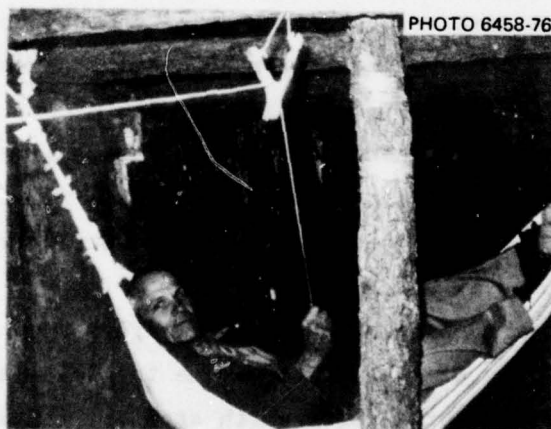
Fig. 4.10. Expedient bed-sheet hammock, useful to avoid severe shock effects in a shelter at high overpressure ranges. The man is operating an expedient shelter ventilating pump via an expedient pulley equivalent, a greased forked stick suspended on strings.

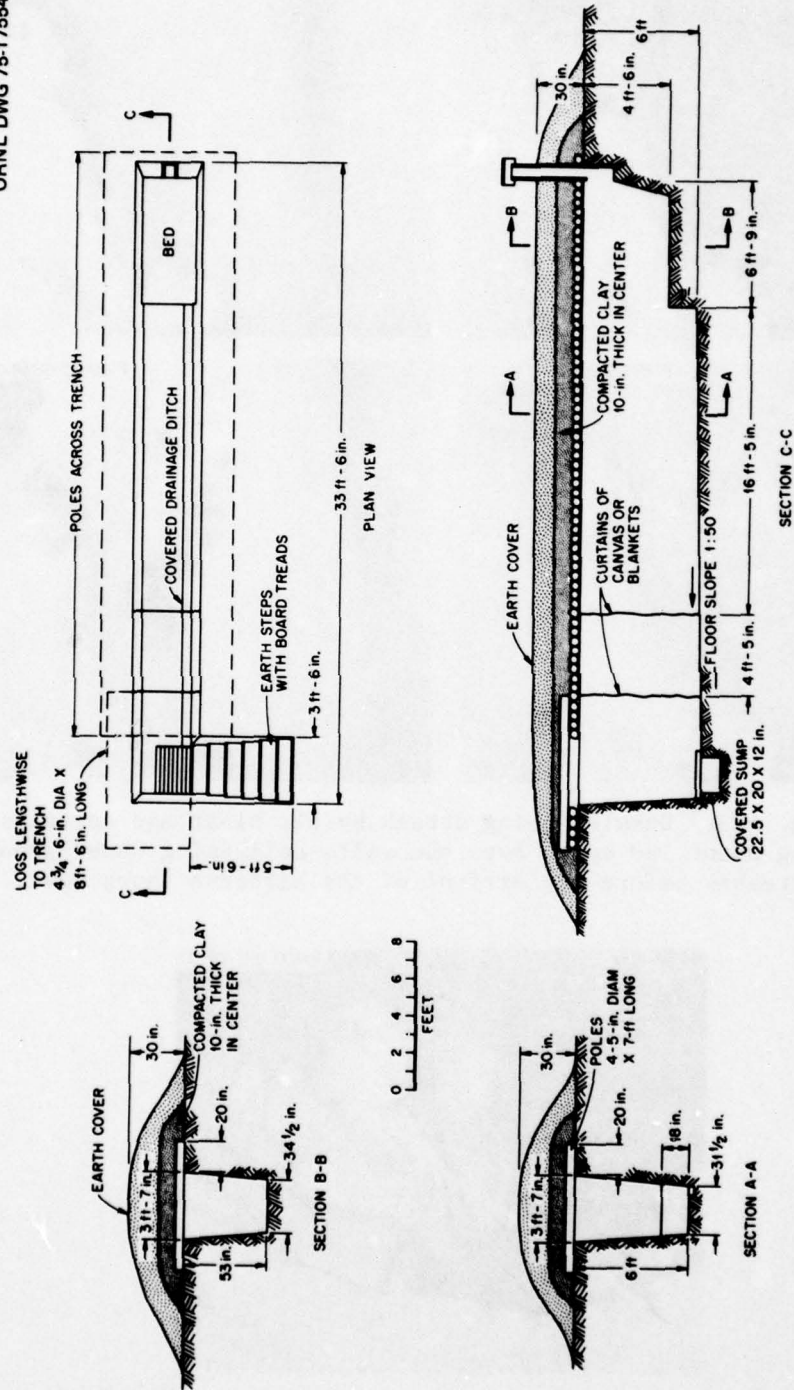
ORNL DWG 75-17554

Fig. 5.2. Russian Pole-Covered Trench Shelter in stable earth.

In the shelter at 20 psi, two anthropomorphic dummies (supplied by the Lovelace Foundation) were seated side by side just inside the inner curtain (see Figs. 5.2 and 5.3). A movie camera was installed by Denver Research Institute for the U.S. Army's Ballistic Research Laboratory. This camera was farther inside the shelter, mounted on a concreted-in-the-ground post. This camera took 400 frames/sec; the four photographs of Fig. 5.3 were taken in 1/100 sec. The first photograph shows only a slight movement of the innermost blanket-curtain. The second shows the earth walls beginning to crumble under the forces of a ground shock wave, induced by the airwave slap overhead before the airborne shock wave reached these walls or the dummies. The third and fourth photographs show the innermost blanket-curtain being torn, revealing the torn outermost curtain, that was darker colored, being blown behind and against it. The collapsing walls trapped the two dummies before the entering blast wind, which was shown by the four movie frames to have a velocity of about 180 mph, could blow them over. (The blast wind peaked at about 470 mph outside this shelter.)

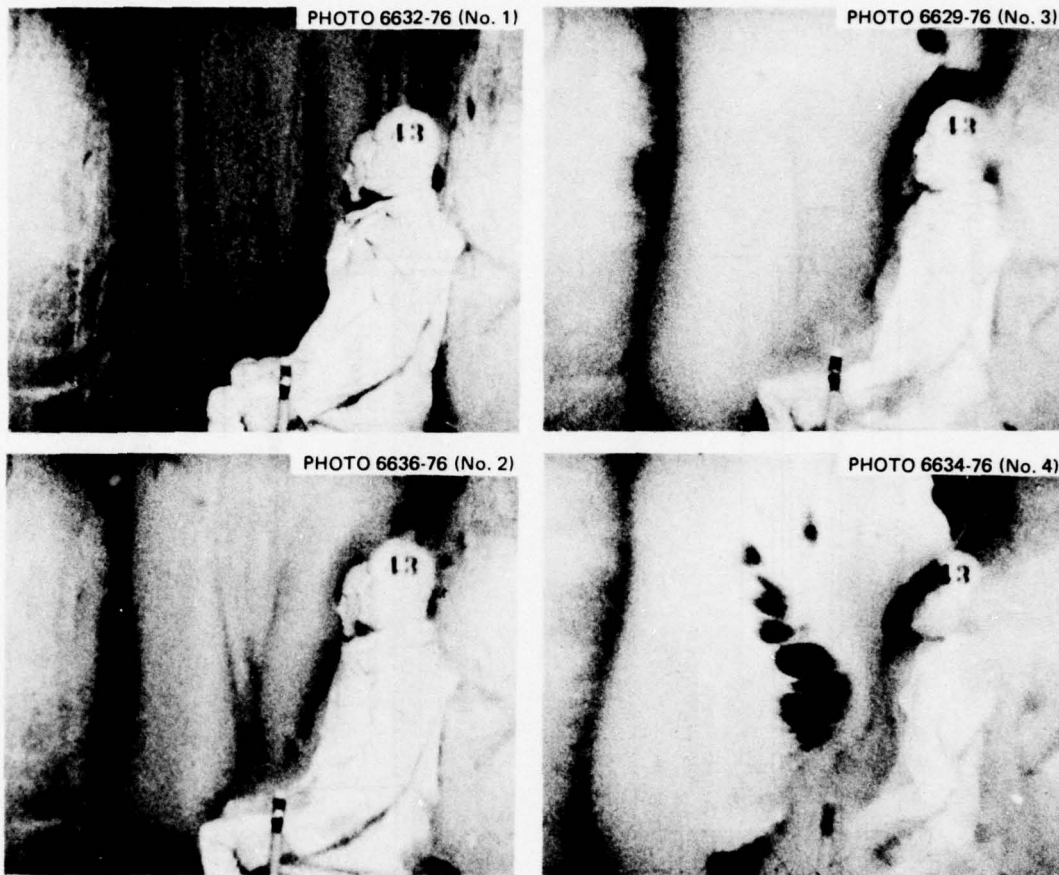
Fig. 5.3. Dummies being struck by air blast and curtains traveling about 180 mph. Note the walls collapsing under ground-shock stresses before the arrival of the airborne shock wave.

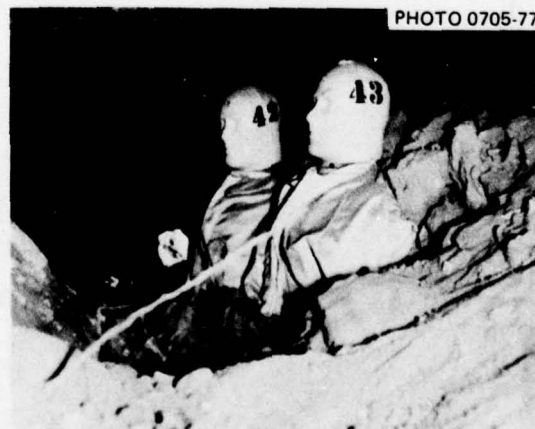
Fig. 5.4. Dummies at 20-psi range after ground shock collapsed the earth walls of shelter. Their steel "bones" and joints prevented them from being knocked down and buried.

5.4.3. Stresses due to ground shocks and earth waves would be the predominant causes of failure of unshored trench shelters subjected to the blast effects of large explosions.

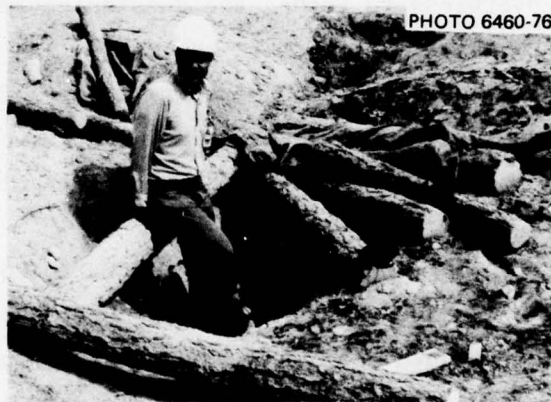
The entry was wrecked and much of its covering earth was blown away, as illustrated by Fig. 5.5. The ventilation duct was broken off.

Fig. 5.5. Wrecked entry of Russian Pole-Covered Trench Shelter at 20 psi.

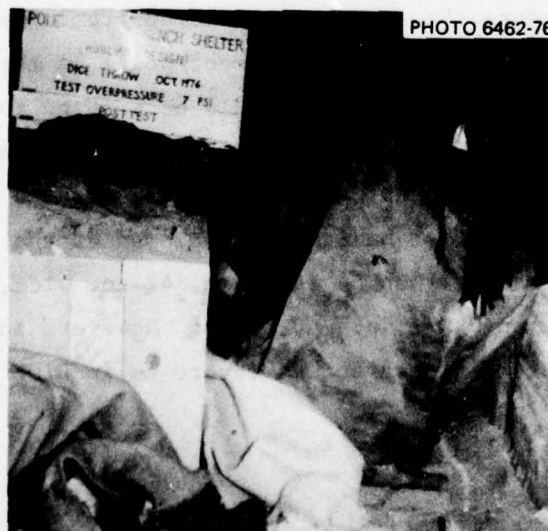
Fig. 5.6. Dummy knocked off bench in Russian Pole-Covered Trench Shelter at the 6.7-psi overpressure range.

At the 6.7-psi range, an identical shelter suffered serious damage. Chunks of hard caliche weighing up to about 400 lb were broken off the very stable earth walls and would have injured shelter occupants. A dummy seated on a fixed bench next to the blanket-curtains was knocked off the bench by the shock wave and the entering blast winds (see Fig. 5.6).

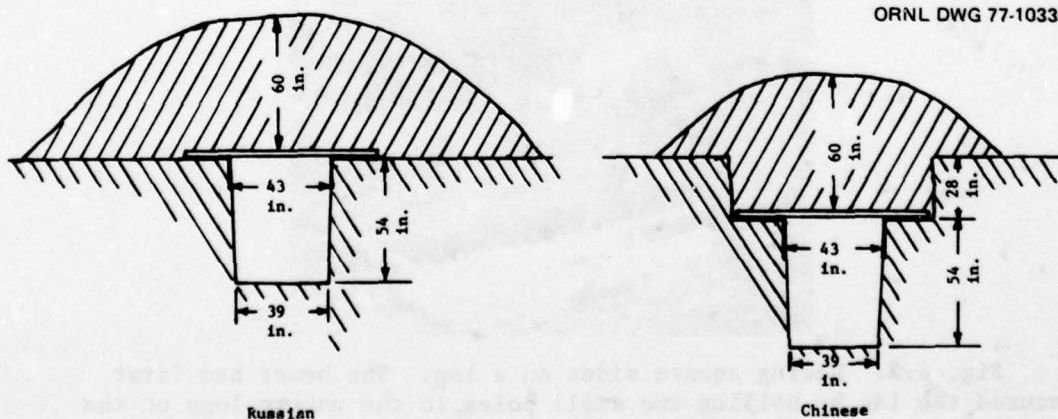
Fig. 6.1. Comparison of Russian way and Chinese way of positioning poles to roof a trench shelter. Note that the Chinese way requires about 35% less earth to be moved in order to make a 5-ft-thick covering — about the thickness specified in a Chinese handbook for shielding against initial nuclear radiation.

As shown in Fig. 6.1, the Chinese half was built with its roof poles resting on earth shelves 28 in. below ground level, cut into the hard caliche. All roof poles (logs) were ponderosa pine. The poles averaged about 5 in. in diameter, not including their bark; all were cut 7 ft long. Earth was mounded about 5 ft above ground level over this whole shelter. This resulted in about 4-1/2 ft of earth covering the roof logs of the Russian half and about 6 ft covering the roof logs of the Chinese half. Blast-wind scouring removed a foot of this mounded dry, loose earth. If blast-wind scouring by a very large explosion had blown away almost all the dry earth mounded above ground level, the Chinese shelter would still have had adequate cover to provide good fallout protection.

This shelter was built with half of its 12-ft-long room having its roof poles positioned in the Russian manner at ground level (see Figs. 5.1, 5.2, and 6.1). The other half of the room had its roof poles positioned in a recommended Chinese manner<sup>17</sup> (i.e., about 28 in. below ground level). Figure 6.1 shows the vertical cross sections of these

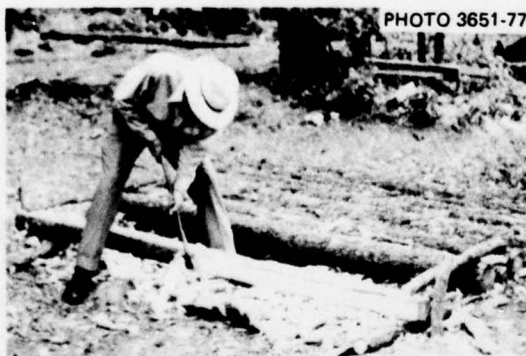
Fig. 6.2. Hewing square sides on a log. The hewer had first secured the log by nailing two small poles to the unhewn logs on the ground and to the already hewn upper side of the log, near its ends. Then he had made vertical ax cuts about 3 to 4 in. apart and at angles of about 45° to the surface of the log. He had made these multiple cuts almost as deep as he planned to make the centerline of the finished flat side. The hewer is shown cutting off long strips, producing a vertical flat side at right angles to the already hewn, horizontal upper side.

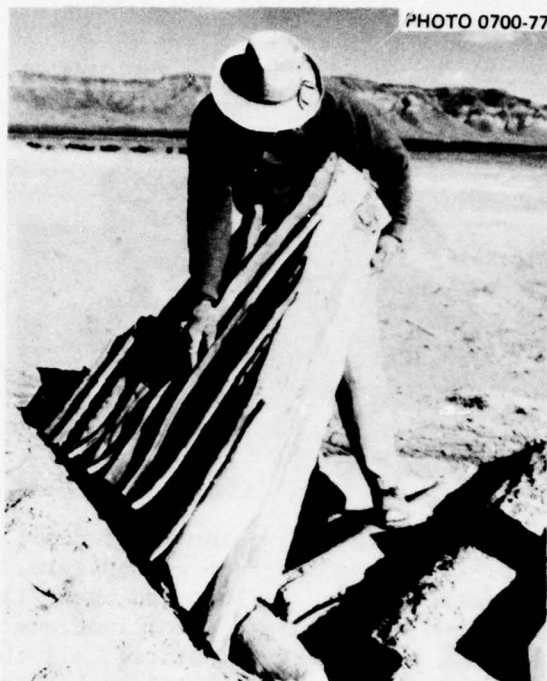
Fig. 6.3. Expedient triangular blast door made of pine poles. The auto-tire flap valves over the 1-1/2-in.-wide spaces between the poles were undamaged by the blast effects at the 53-psi overpressure range. Ground zero was to the left, in prolongation with the hinge pole of the door. Blast effects had moved the three connected blast-protector logs, preventing the door from being opened fully.

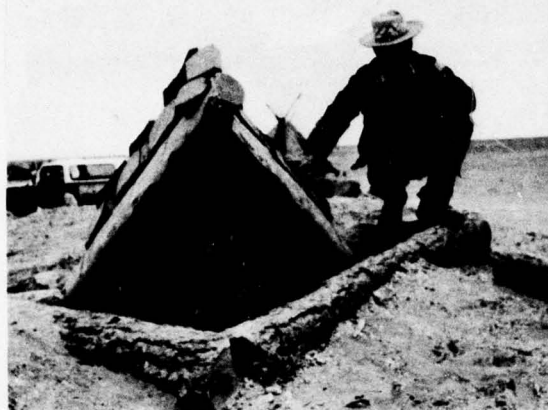
PHOTO 6442-76

Fig. 6.4. View of the same triangular blast door, looking in a direction perpendicular to the radius from ground zero. The hinge pole, originally 7 in. in diameter after peeling, had been flattened on its top and back side. The two other poles, 8 in. in diameter, had been flattened on their bottom, top, and inner sides. All three outer poles were notched and nailed together. Note the slots between the door-covering poles.

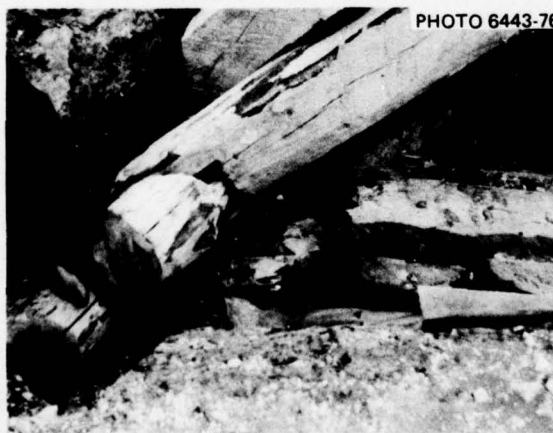
PHOTO 6443-76

Fig. 6.5. Broken pole of triangular door seat. This pole was broken by differential movements of the earth mounded over the shelter. The man's hand rested on the unbroken hinge pole.

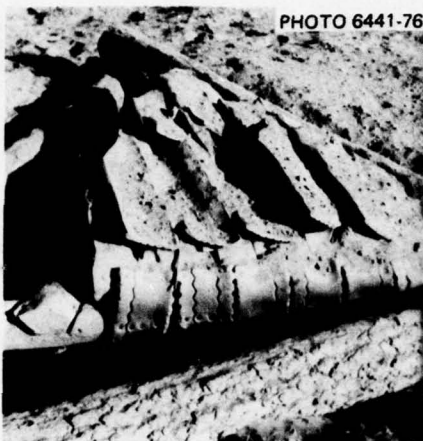
Fig. 6.6. Posttest condition of expedient triangular blast door. Some flap valves had been jammed shut, and much earth and sand had been deposited.

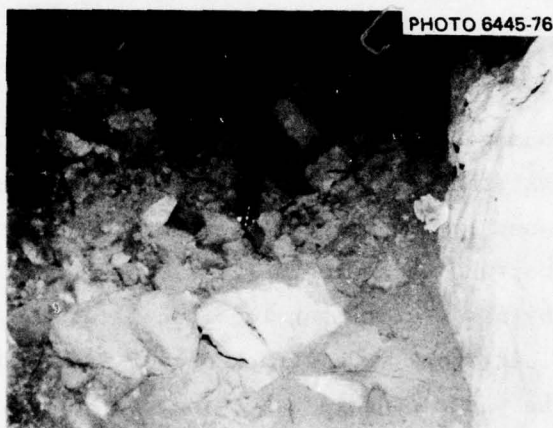
PHOTO 6445-76

Fig. 6.7. Postshot view of the caved-in caliche walls of the "Russian" half of the Log-Covered Trench Shelter at 53 psi.

Although not one roof pole of any part of this shelter or any other shelter was broken or cracked, the ground-shock effects collapsed the walls of the Russian half of this shelter so badly (see Fig. 6.7) that all occupants would have been killed. Damage to the Chinese half was much less serious, although hundreds of pounds of caliche, some chunks weighing up to 20 lb, were broken off the edges of the shelves supporting the roof logs. The roof deflection gauge in the Chinese half recorded a maximum transient downward deflection of 1-1/2 in. and a permanent deflection of 7/8 in.

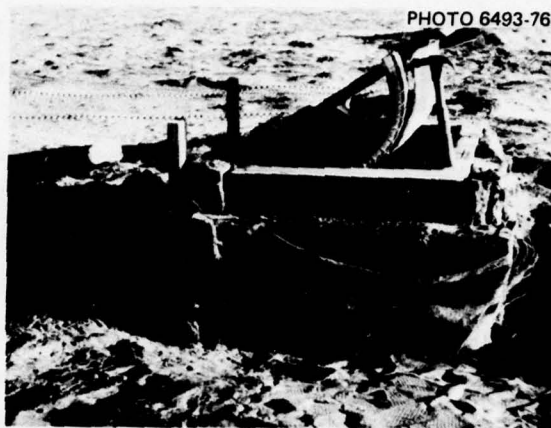
PHOTO 6493-76

Fig. 7.1. Semiexpedient blast door made of a 30-gal steel drum, badly damaged at 31 psi but still blast-tight. Blast-wind scouring had removed up to 17 in. of the dry earth mounded around this entrance and blown away its single blast-protector log.

This shelter was constructed the same as the Log-Covered Trench Shelter at 53 psi, except that protecting its single entry it had a semiexpedient blast door made of about 65% of a 30-gal steel oil drum. Rubber-tire hinges and rubber-tire seals made a snug closure between the door and the upper part of the vertical entry. The upper 2 ft of the vertical entry was made of two thicknesses of 2-in. boards nailed together (see Fig. 7.1).

Although the blast effects loosened some of the bolts of the steel blast door, tore the metal in several places, and produced other damage indicating that it was on the verge of failure, it did not fail.

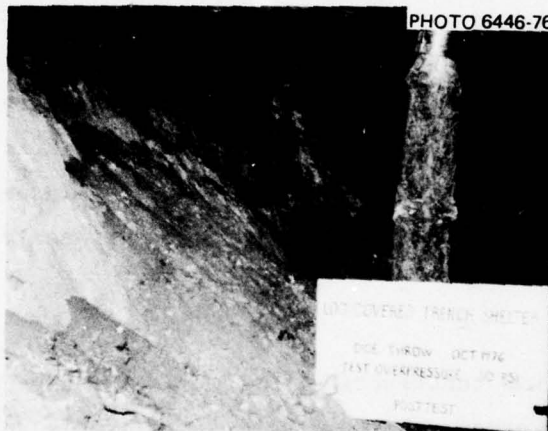
PHOTO 6446-76

Fig. 7.2. Serious wall caving at 31 psi (predicted 30 psi). The beam deflection gauge on top of the post showed a 2-1/2-in. lowering of the center roof log.

Figure 7.2 pictures the interior of the Chinese half of the shelter after the blast had broken hundreds of pounds of caliche off the very stable walls and lowered the roof poles from an estimated maximum of up to 6 in. at some lower ends on the side nearest ground zero to a minimum of about an inch at some of their opposite ends. This lowering did not cause the roof to collapse. No poles were cracked in any part of this shelter. The walls of the Russian half collapsed so badly that all occupants would have been buried.

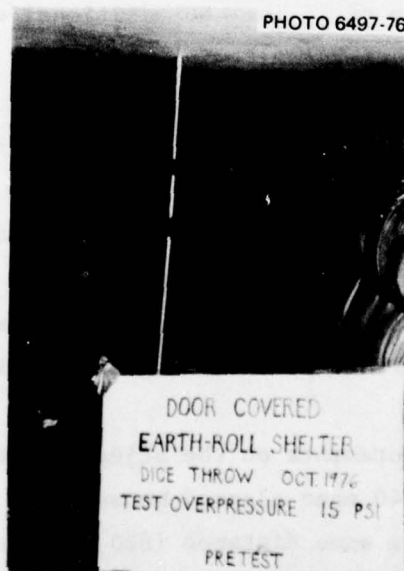
Fig. 8.1. Bed-sheet "earth-roll" walls 36 in. apart before test.

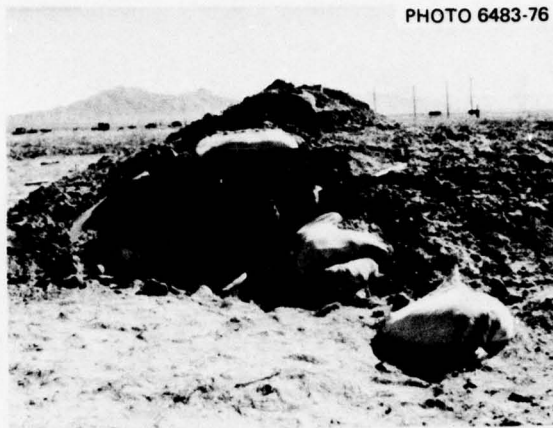
PHOTO 6483-76

Fig. 8.3. Northward-facing entry (at right angle to the direction to ground zero) of Door-Covered Earth-Roll Shelter at the 15-psi overpressure range. This is a posttest photograph.

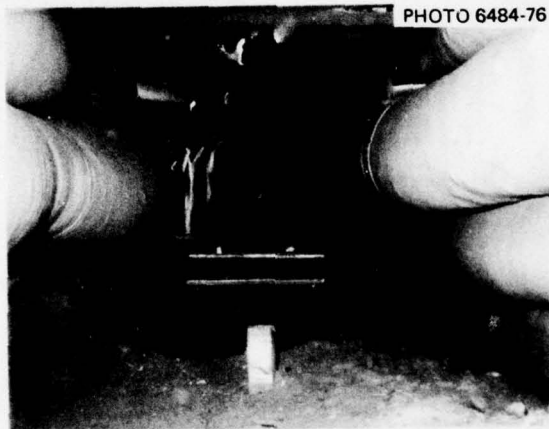
Fig. 8.4. Interior of Door-Covered Earth-Roll Shelter after 15-psi blast effects had reduced width of shelter from 36 in. to a minimum of 14 in. near its center.

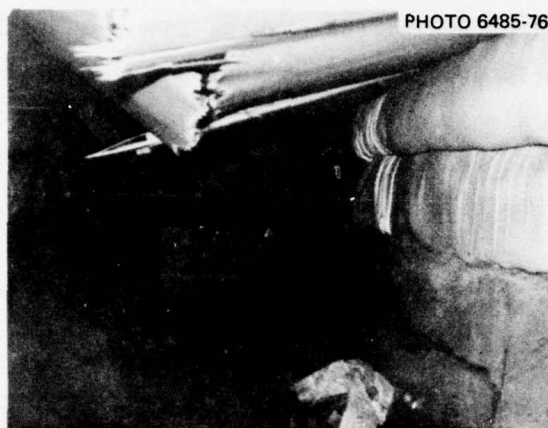
Fig. 8.5. Posttest interior of Door-Covered Earth-Roll Shelter at 5.8-psi overpressure range. The lower 1/8-in. veneer of the doors had been badly broken by impact before the test, due to a front-end loader having dumped tons of earth onto this yielding roof.

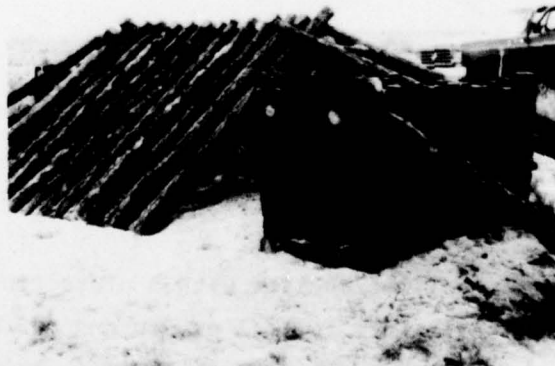
PHOTO 6405-76

Fig. 9.1. Almost completed frame of Ridge-Pole Shelter at 15 psi. Only the outermost roof pole of the entry had been placed on its wall poles.

In wooded areas having the water table or rock too close to the surface for below-ground expedient shelters to be practical, untrained families with few tools have been able to build Ridge-Pole Shelters in less than 48 hr.<sup>12</sup> No prior blast testing of this type of shelter, which has its side poles merely leaning against its ridge pole, had been carried out anywhere (see Fig. 9.1).

and the other entry facing in the opposite direction. Figure 9.1 shows the almost completed pole frame, plus a temporary brace pole steadying the entrance. The pole frame was next covered with small, leafy limbs (Fig. 9.3), which in turn were covered with 4-mil polyethylene. Then a covering of dry, sandy earth 2 ft thick was placed over the whole shelter, with earth-filled potato bags retaining the earth over the entrances.

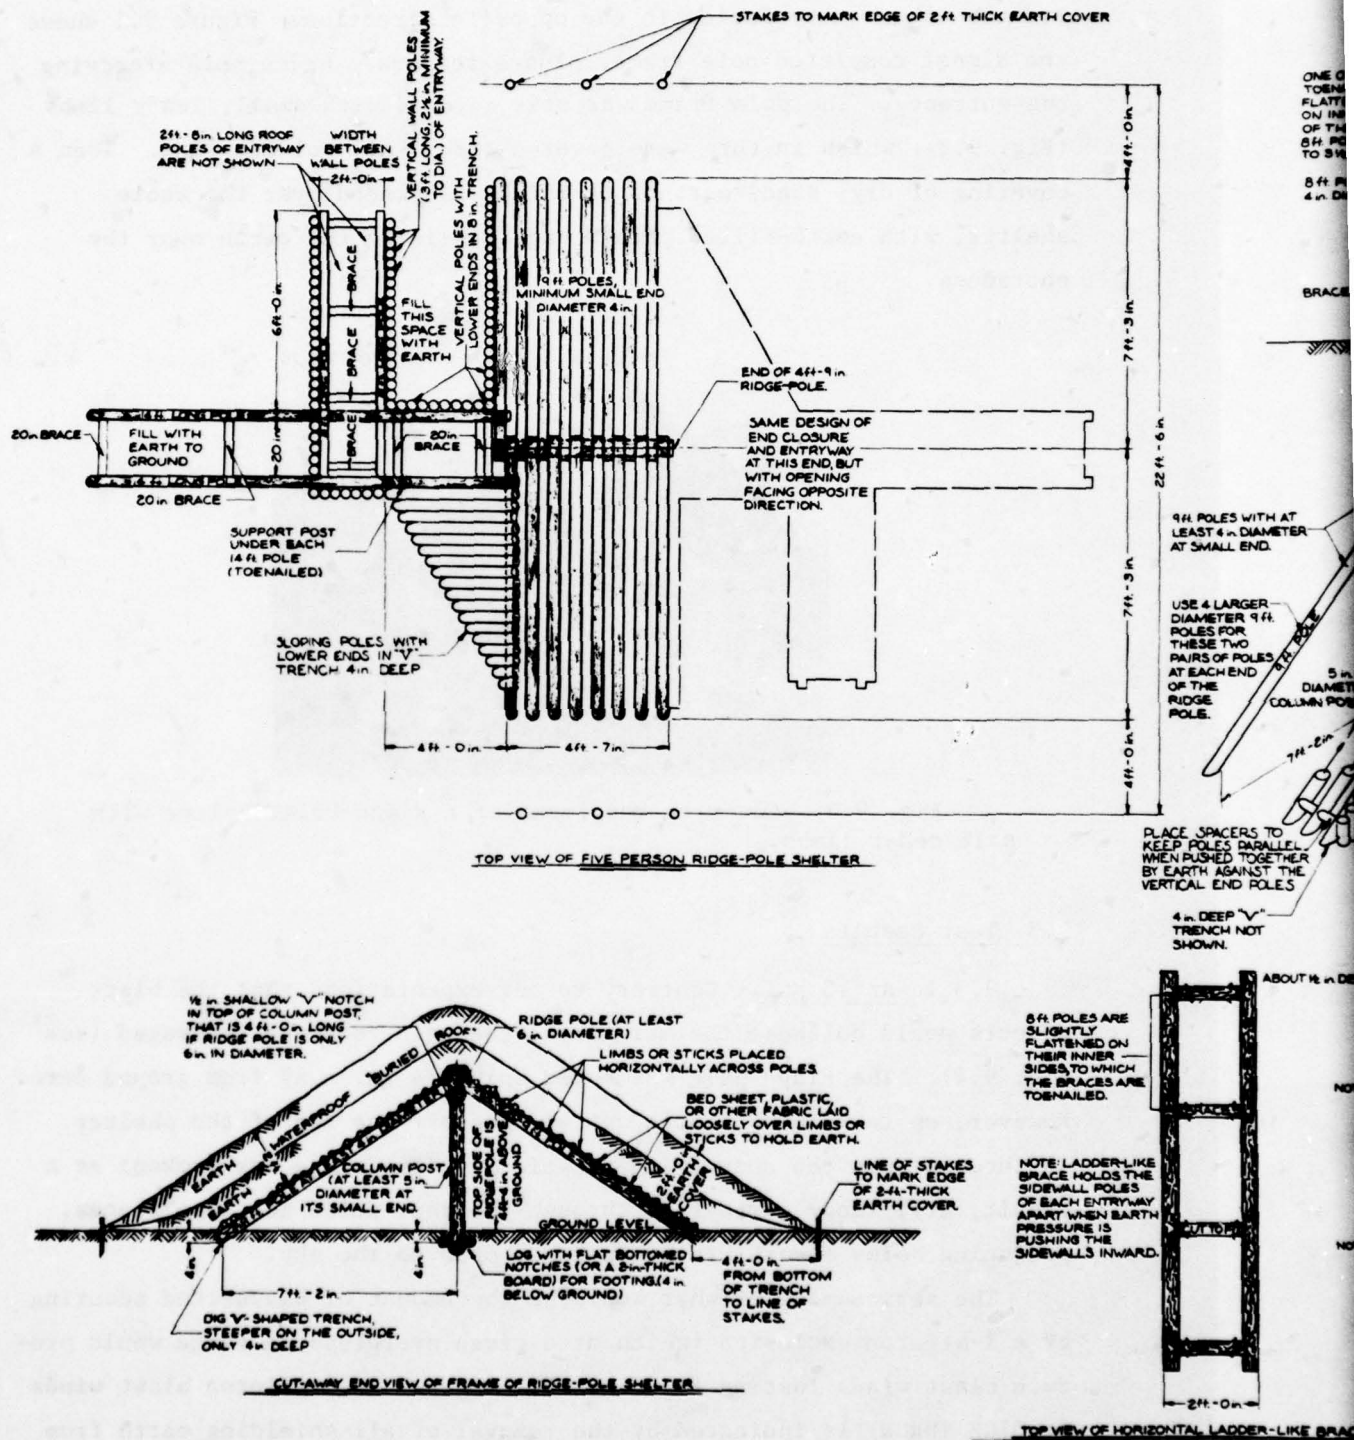
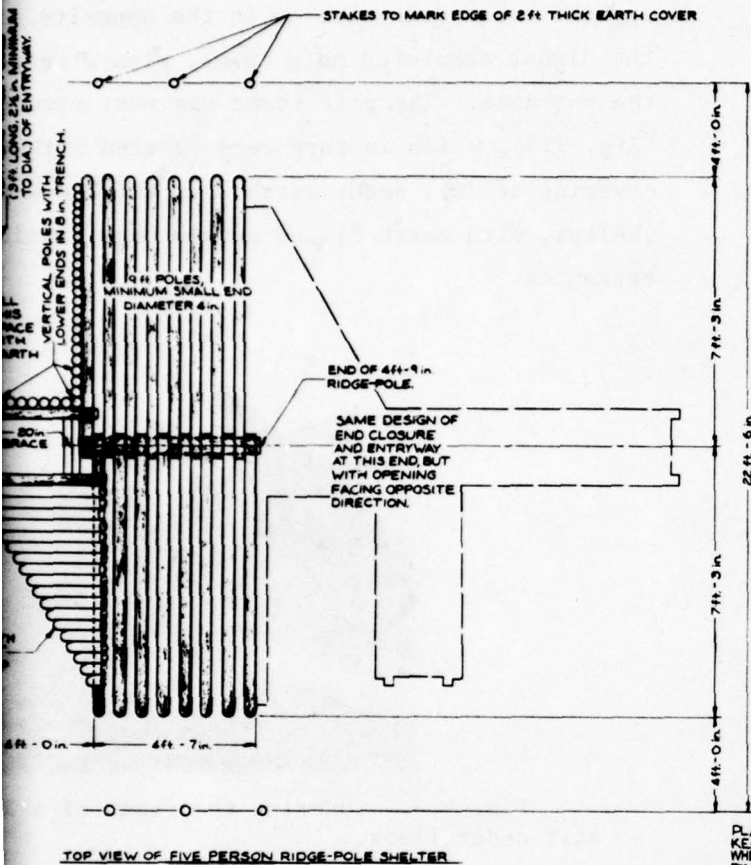
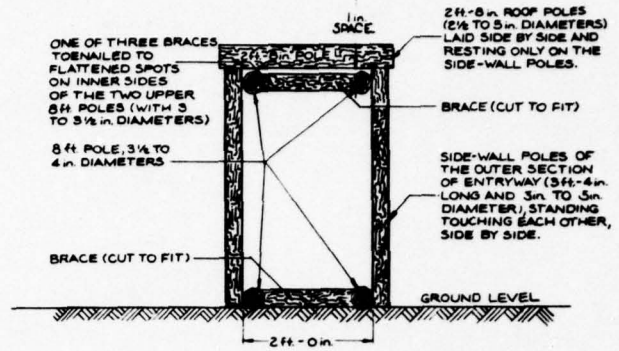
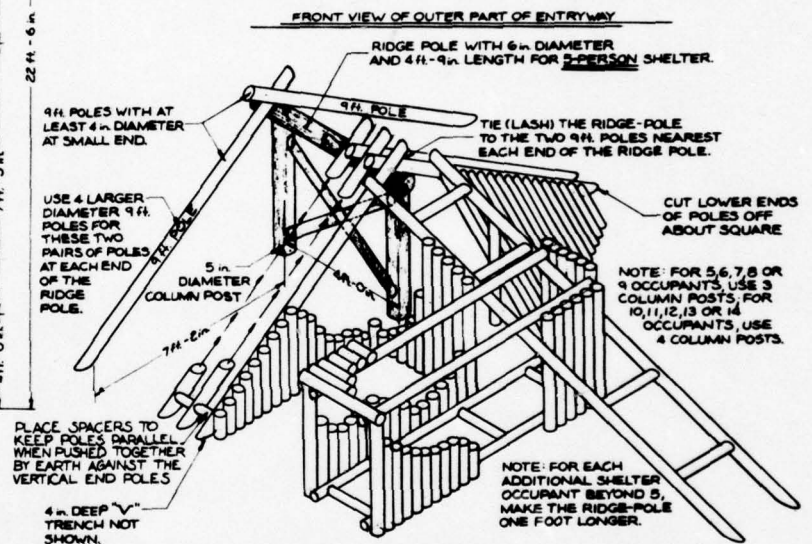
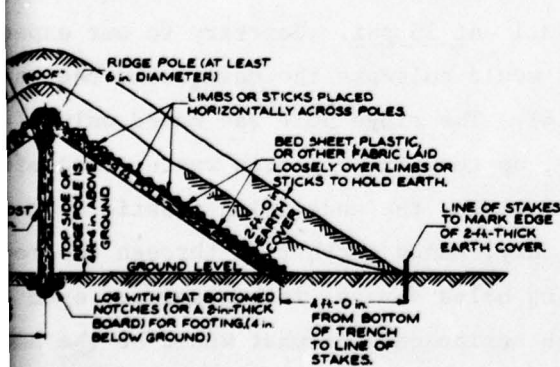
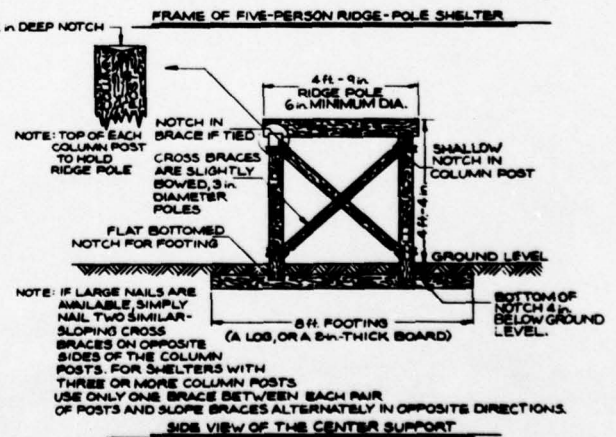
Fig. 9.2. Ridge-Pole Shelter tested at 15 and 5.8 psi.

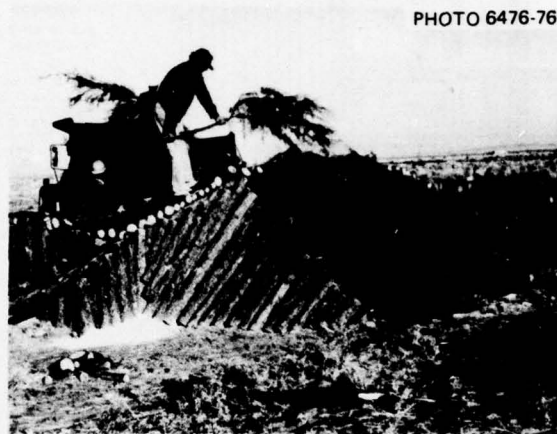
Fig. 9.3. Covering the frame of a Ridge-Pole Shelter with salt cedar limbs.

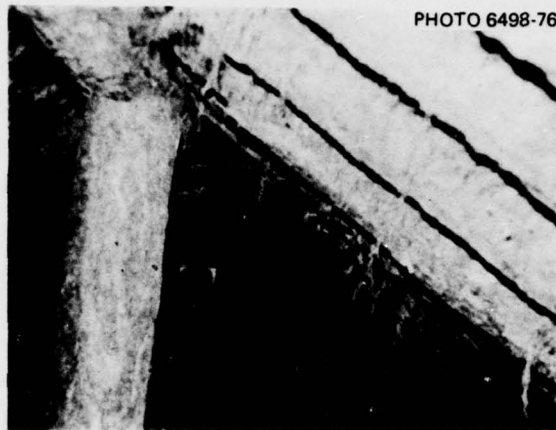
Fig. 9.4. Posttest interior of Ridge-Pole Shelter at 15 psi. The main room was undamaged; the ridge pole had been moved only 3/4 in. away from ground zero.

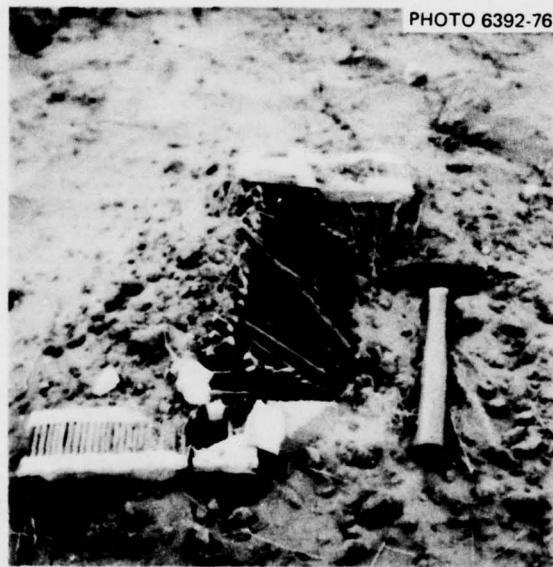
Fig. 9.5. Posttest exterior of 1/10-scale Ridge-Pole Shelter at 15 psi. Scouring by the blast winds had removed practically all the earth, plastic, and twigs on the side facing ground zero and over the two entries — indicative of blast-wind scouring of earth cover over a full-scale shelter by a megaton explosion.

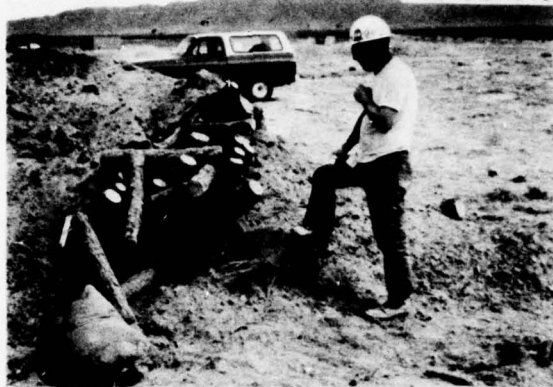
Fig. 9.6. Collapsed entrance facing away from ground zero, at 15 psi. The blast winds had scoured away most of the covering earth, and the earth had "flowed" away from the center of the shelter, pushing the upper part of the entry in a direction perpendicular to the radius from ground zero.

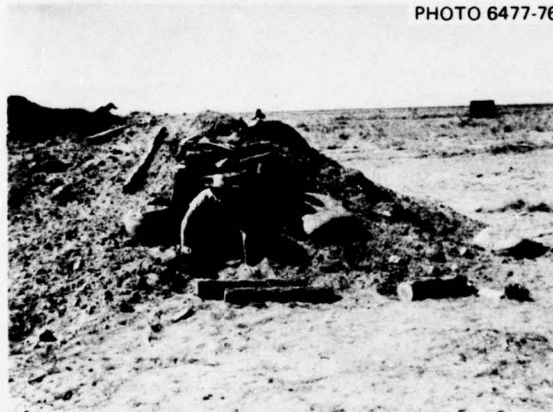
Fig. 9.7. Postblast view of the entry of the Ridge-Pole Shelter facing ground zero, at 15 psi. Note the scattered potato-sack sandbags that had been placed to retain the earth over the entry. Earth "flow" had pushed all but the base of the entry away from the middle of the shelter, leaving none of the entry walls perpendicular.

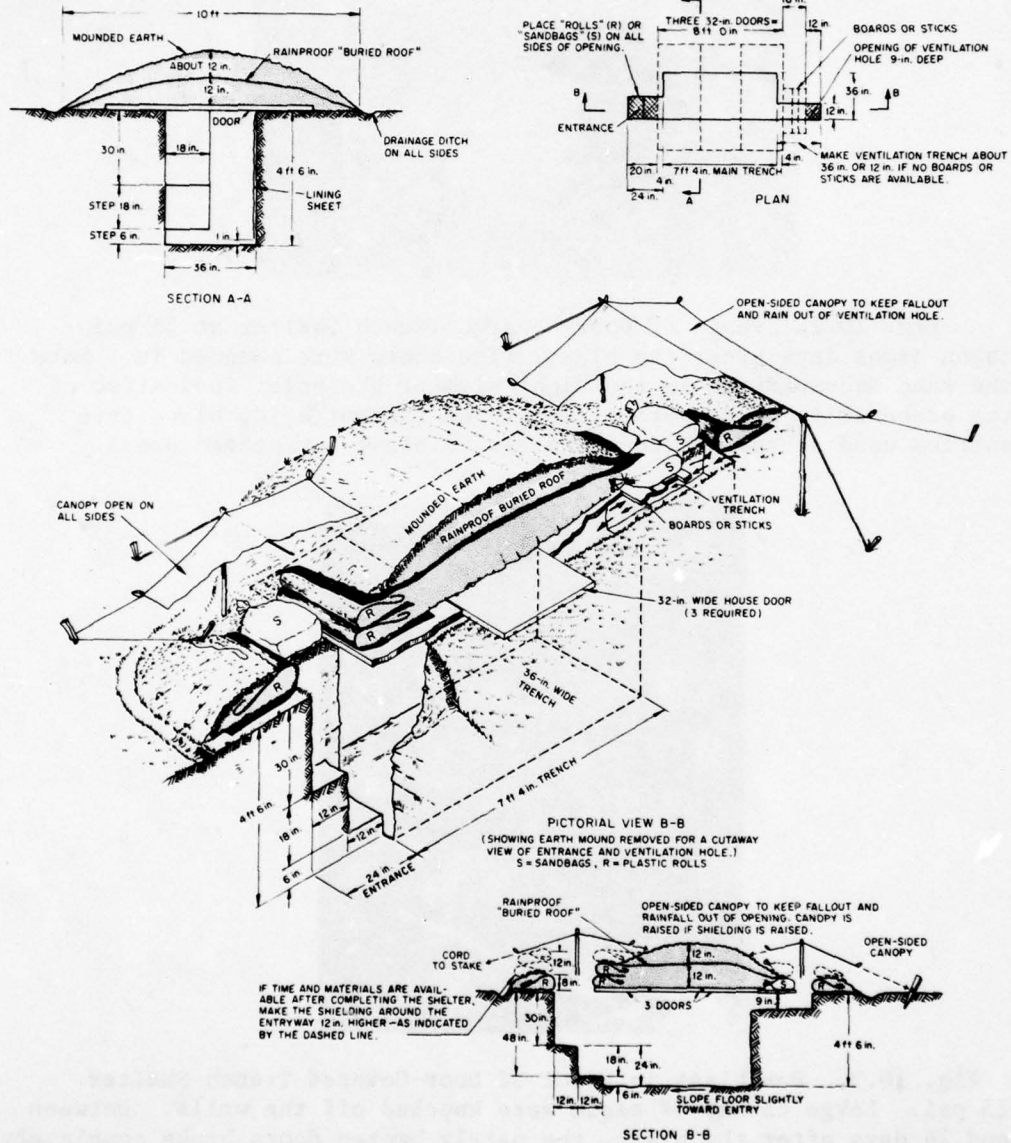
Fig. 10.1. Door-Covered Trench Shelter tested at 31 and 15 psi.

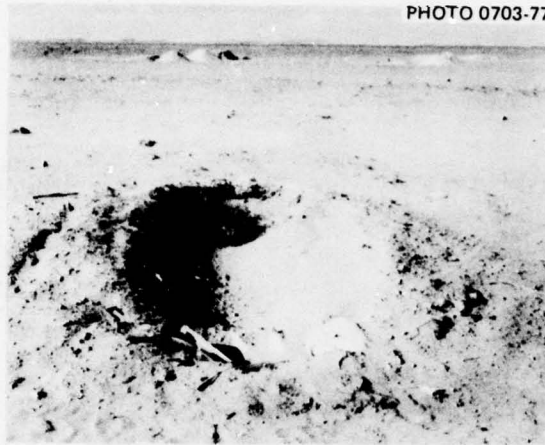
Fig. 10.2. Photo of Door-Covered Trench Shelter at 31 psi taken eight days after the blast. The doors were smashed in. Note the sand accumulation in the right side of the hole, indicative of the probability of dangerous amounts of fallout being blown into entries used as ventilation openings in blast-devastated areas.

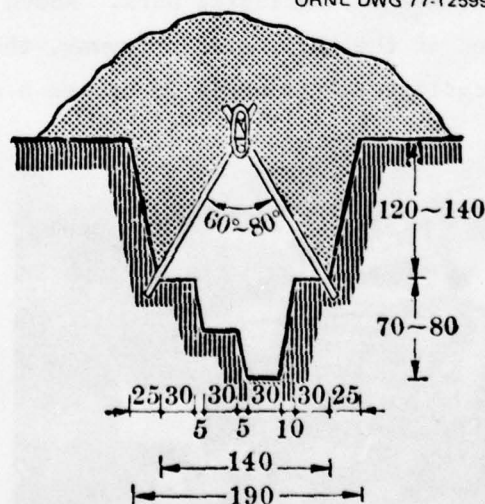
ORNL DWG 77-12599

图 3-107 人字形骨架避弹所

Fig. 11.1. Chinese "Man" Shelter tested at 20 psi. This shelter is called "Man" Shelter in a Chinese civil defense handbook because a cross section of its frame resembles the Chinese character "人" for "man."

In the first Chinese handbook<sup>17</sup> on nuclear defense that came into our hands, we saw the shelter illustrated by Fig. 11.1. Previously, we had never seen or conceived a blast shelter of this design or one built of such thin poles. If such thin poles could safely be used, it would reduce the labor of obtaining the poles for an expedient blast shelter — one of the chief constraints on the practicality of such shelters. Therefore, we decided to blast test this Chinese design.

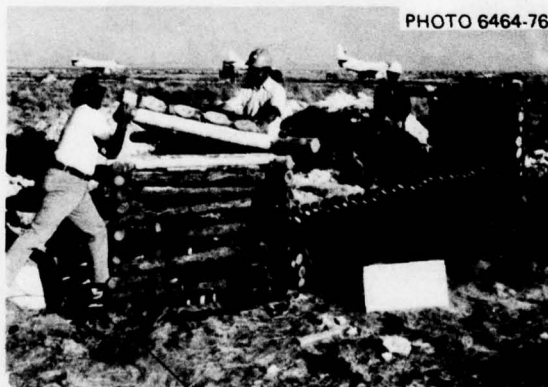
Fig. 11.2. Completed frame of Chinese "Man" Shelter tested at 20 psi. In accord with the Chinese drawing, the poles of the main room averaged only about 3 in. in diameter. The triangular entries and triangular blast doors were of ORNL designs.

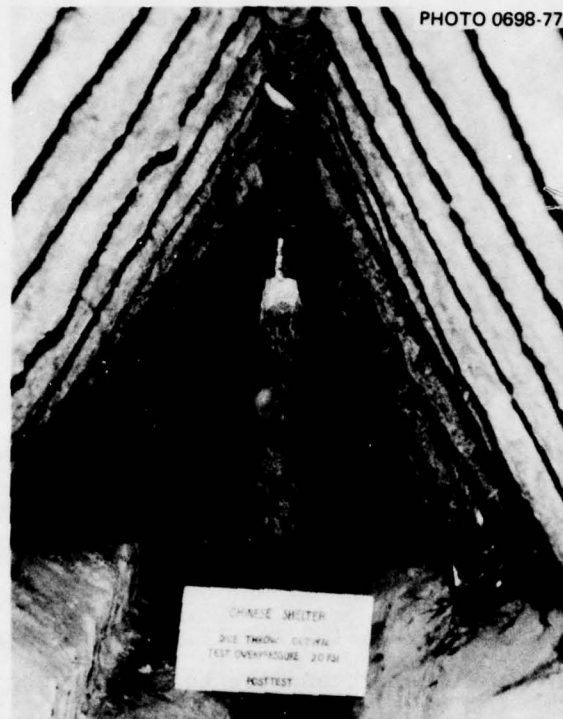
Fig. 11.3. Undamaged interior, showing earth bench on one side and roof deflection gauge on post.

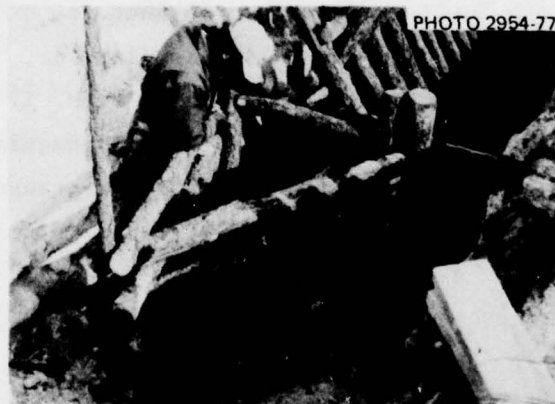
Fig. 11.4. The lower part of the vertical triangular entry is pressed horizontally against two pairs of vertical posts. Each pair is wired together. The two pairs are held apart by two horizontal spacer poles toenailed in place to frame the rectangular opening between the horizontal and vertical parts of the entry. The pairs of vertical posts are pressed against two horizontal poles (the uppermost is shown) that in turn press against both the outermost two poles of the horizontal part of the entry and the earth in two slots dug in the sidewalls of the excavation.

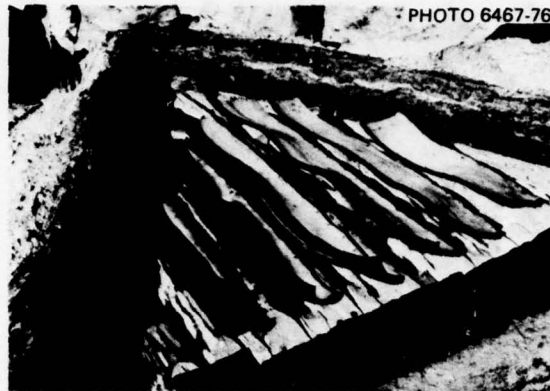
Fig. 11.5. Posttest undamaged triangular blast door, made of three 5-in.-diam peeled poles covered with seven 4-in.-diam peeled poles. Between these covering poles were six 2-in.-wide ventilation slots, protected by six flap valves made of strips cut from worn tire treads.

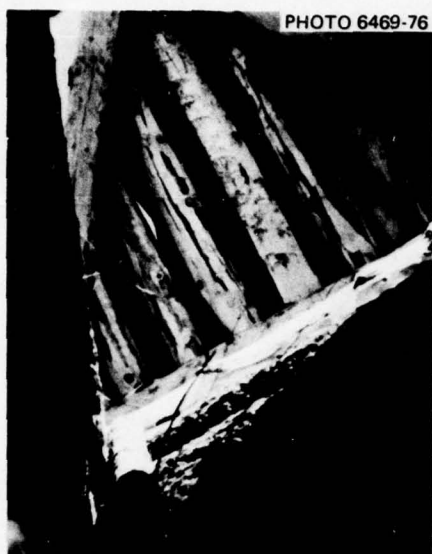
Fig. 11.6. Undamaged triangular blast door, partly open, and viewed looking up the side of the triangular entry to which the door was hinged.

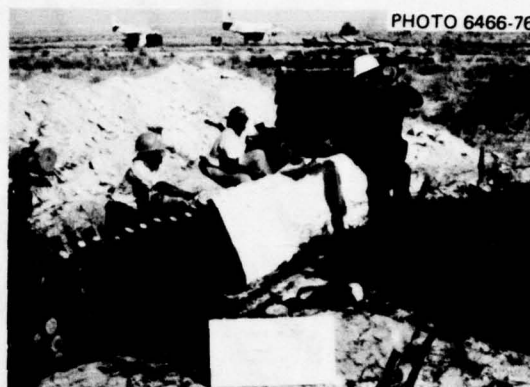
Fig. 11.7. Covering the limb-covered pole frame with bed sheets. Salt cedar limbs had first been placed crosswise over the lightly constructed pole frame.
